TIMBER PEST INSPECTION REPORT

BOO-20656-C7Z5S5
Report Number

4 Indura Road, Narrabeen, NSW 2101
Inspection Address

13/03/2018
Date of Inspection

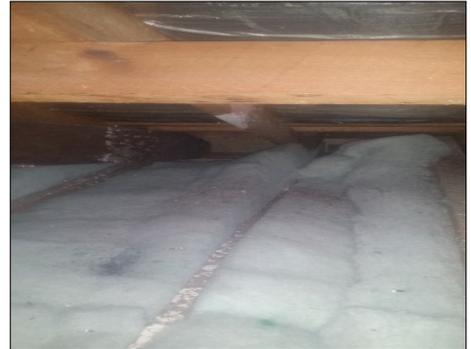
Visual inspection to some timbers in the roof void were obstructed due to the design of the roof which restricted bodily access.

No access due to flat roof/raked sections, therefore no inspection to this area.

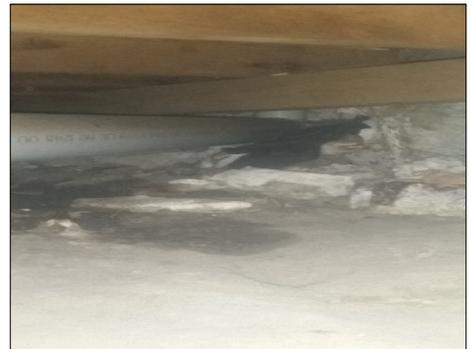
Sub-Floor because:

Vertical clearance low in sections (unreasonable access to these sections).

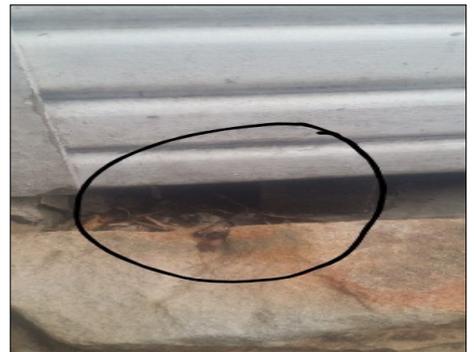
Timber bearer at rear of dwelling should be at least 75mm above finished ground levels to prevent wood decay and possible termite entry. Recommend clearing soil and debris from this area to achieve the required clearance.

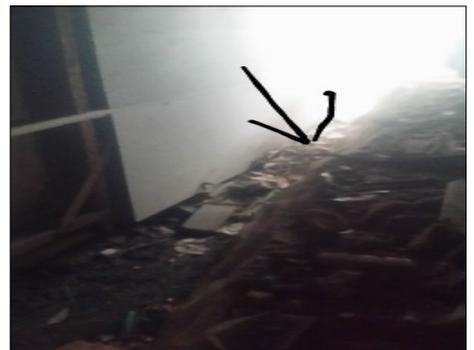
Cladding/timber framing is in contact with the ground, this can lead to undetected termite entry and wood decay. Strongly recommend clearing all soils away from this area. 75mm clearance is required below the cladding and timber frame. Regular monitoring of this area will be required to help detect any termite activity.

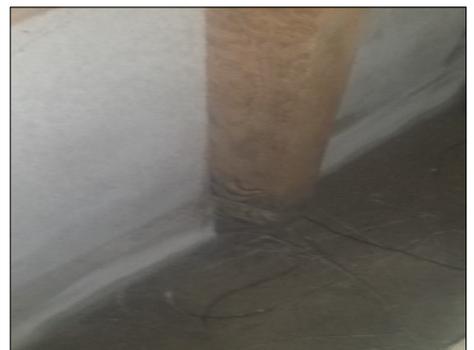
Various subfloor walls / partitions are non-conforming, unprotected and bridging ant capping. Recommend chemical treatment to subfloor walls, removal or replacement using a suitable material.

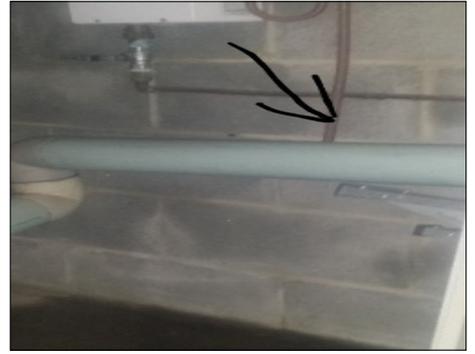
Recommend diverting HWS overflow away from sub floor area.
