BUILDING & TIMBER PEST INSPECTION REPORT

In accordance with AS 4349.1 & 4349.3

10356
Report Number

19 Eungai Place, North Narrabeen, NSW 2101
Inspection Address

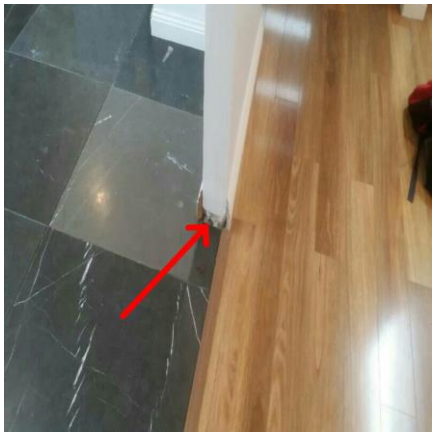
Moisture damage to top level bathroom door architrave adjacent shower recess. Suggests previous leaks. Recommend to monitor for any further changes/staining, if so, further investigation into the cause of the leaking may be required.
